# Manhole Inspection Summary

Manhole # S29M\_\_009MH

Insp Date: **12/8/08 1:55 PM**

**Location** Address: **835 W.Barre St.**

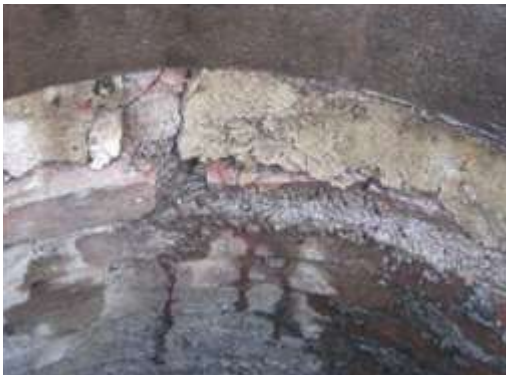
Defect 4

Infiltration: ☐ None ☐ Joint ☐ Cracks ☒ **Mortar** ☐ Roots ☐ Wall

chimney infiltration

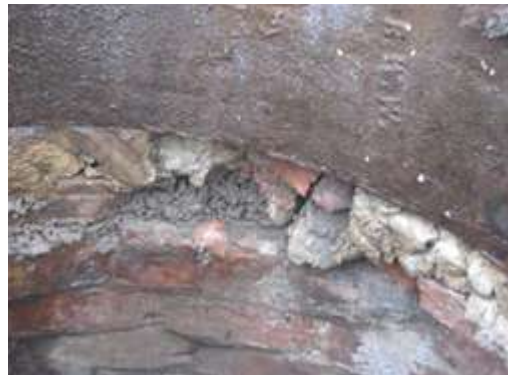
Defect 3

Condition: ☐ Sound ☐ Cracked ☐ Root Intrusion ☒ **Loose Brick** ☐ Deteriorated

missing brick and mortar with chimney infiltration

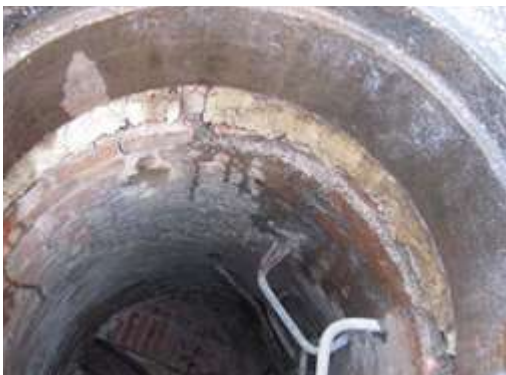
Defect 5

**Frame** Offset: **0** (in.) Condition: ☐ Sound ☐ Cracked ☒ **Leaks**

Infiltration: ☐ None ☐ Joint ☐ Cracks ☐ Mortar ☐ Roots ☒ **Wall**

Frame, corbel infiltration

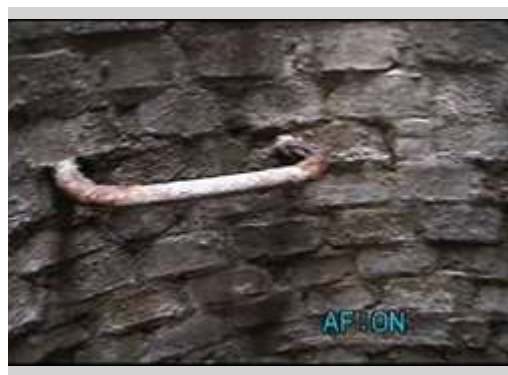
Defect 2

**Steps** Count: **6** Missing: **0** ☒ **Corroded**

corroded step

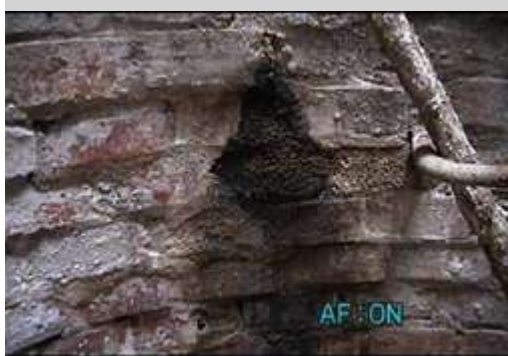
### Defect 1

Infiltration: ☐ None ☒ **Joint** ☐ Cracks ☐ Mortar ☐ Roots ☐ Wall

barrel infiltration

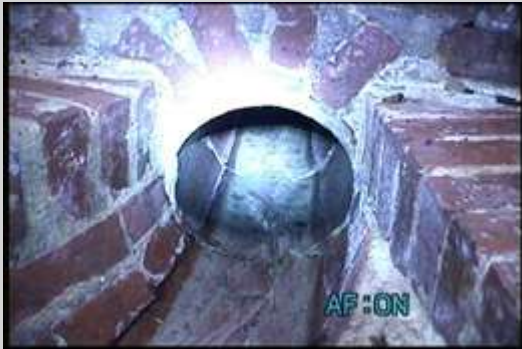
12 O'Clock Outflow

Pipe Height: **8.4** (in.) Rod and Bar (Angled)  
Pipe Material: **Clay** ☐ Pipe Lined  
Invert Depth: **10.14** (ft.) Flow Characteristics: **Slow**  
Deposits: ☒ None ☐ Mud ☐ Sludge ☐ Debris ☐ Grease  
Silt Depth: **0** (in.) Deposits Extent:  
Infiltration: **None** Pipe Seal Cond: **Sound**

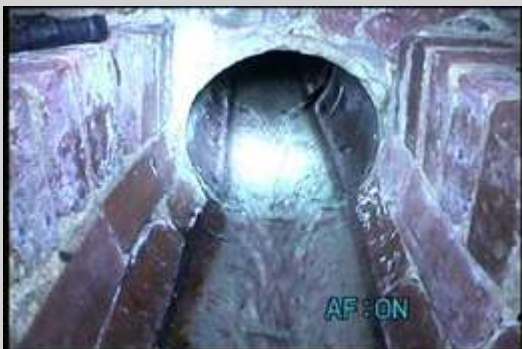
8 O'Clock Inflow

Pipe Height: **8.4** (in.) Rod and Bar (Angled)  
Pipe Material: **Clay** ☐ Pipe Lined  
Invert Depth: **10.06** (ft.) Flow Characteristics: **Slow**  
Deposits: ☒ None ☐ Mud ☐ Sludge ☐ Debris ☐ Grease  
Silt Depth: **0** (in.) Deposits Extent:  
Infiltration: **None** Pipe Seal Cond: **Sound**
